F-8-35
Cramer House
Private

MARYLAND INVENTORY OF
HISTORIC PROPERTIES

Survey No. F-8-35

**BEATTY-KRAMER HOUSE (WITH SPRINGHOUSE
AND SMOKEHOUSE)
CERESVILLE VICINITY
FREDERICK COUNTY, MARYLAND**

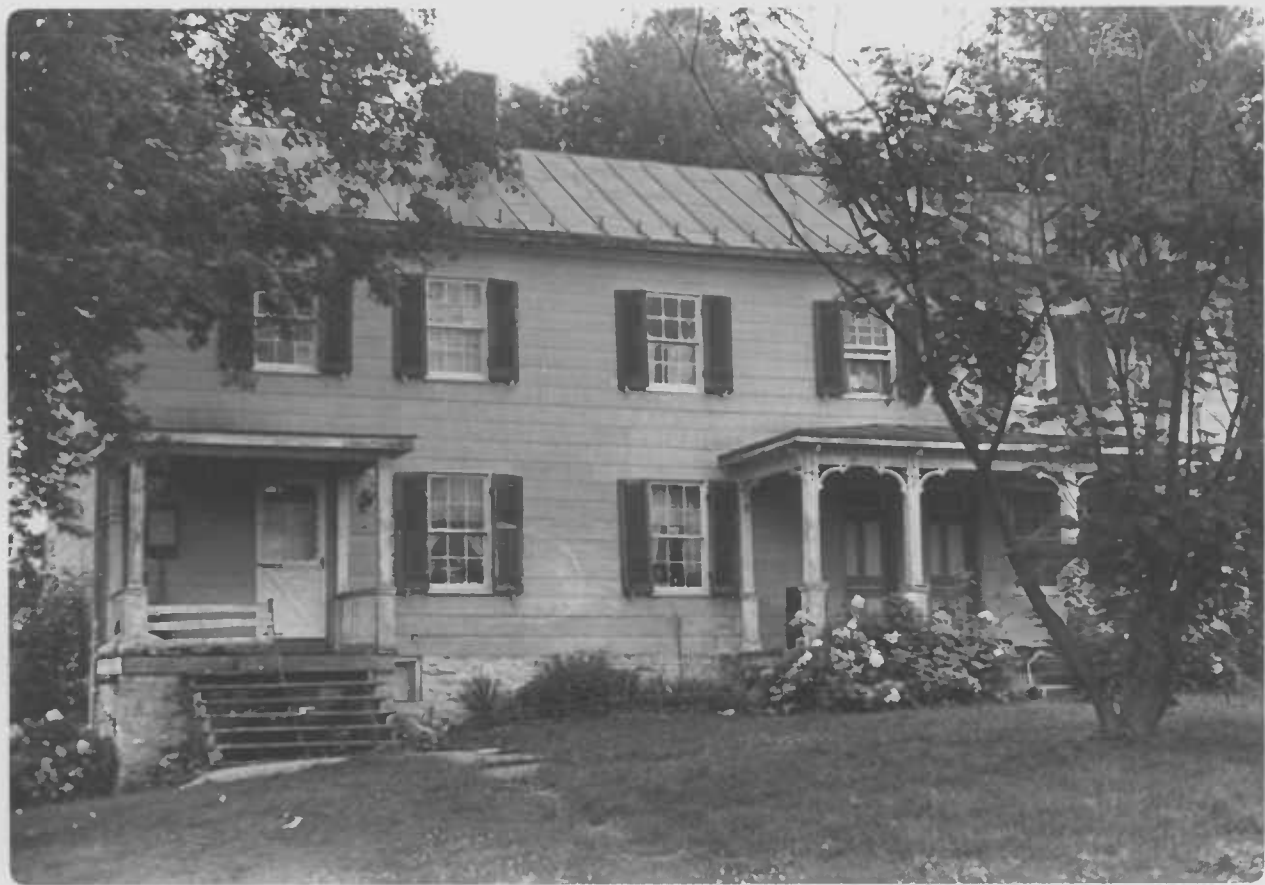
F-8-35

Cramer House
north elevation

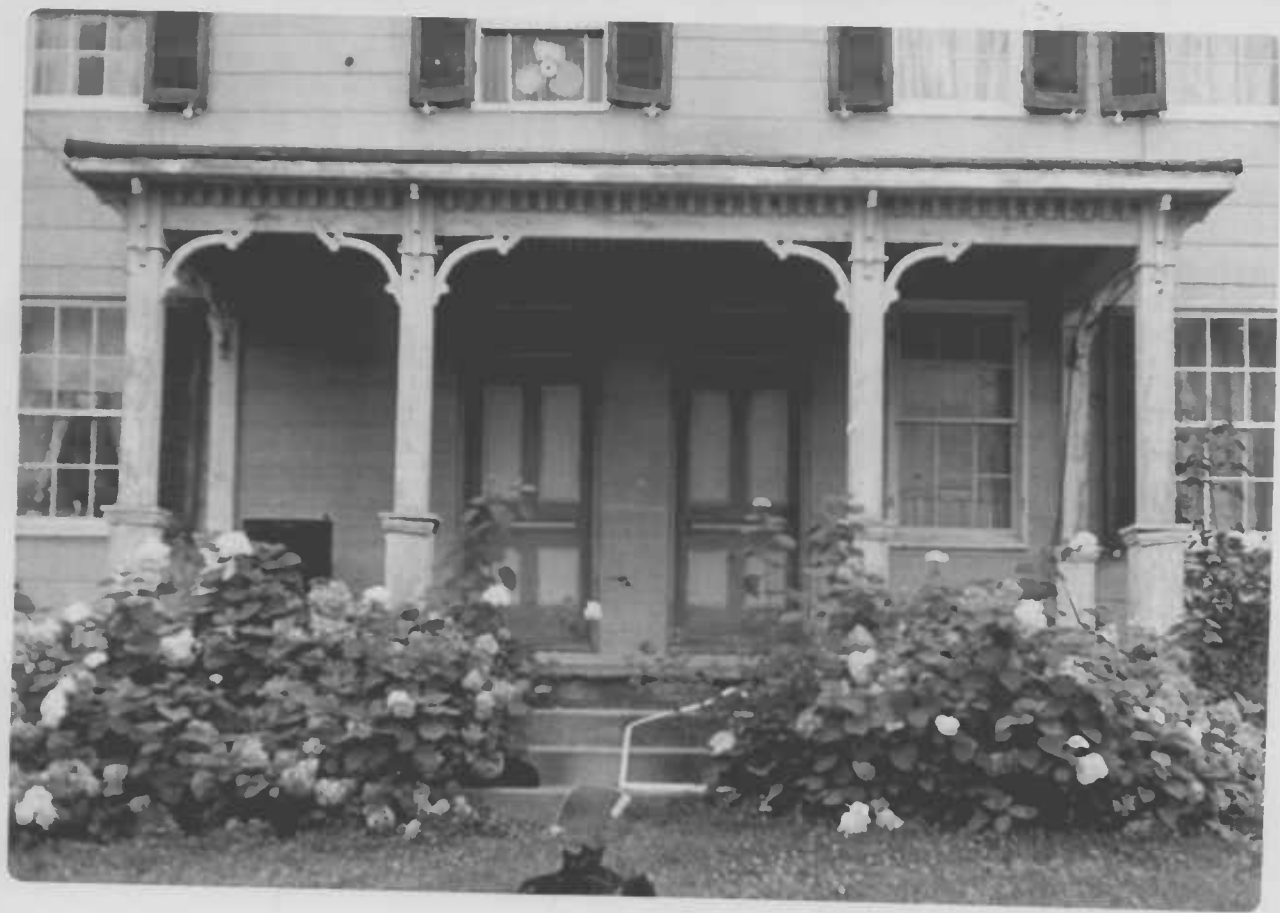
F-8-35

Two entrance porches are found on the facade. A one bay entrance porch is located on the west wing of the house. The porch is supported by four plain columns with slatted railing framing the columns. The porch rests on a stone foundation and is covered with a standing seam tin roof. Beneath the roofline is a plain boxed cornice. The second porch added in the 1860's, is the more decorative of the pair. The three bay entrance porch is supported by plain wooden columns trimmed with decorative brackets. A dentil cornice lies beneath a standing seam tin roof.

Detail - Porch
E/Wing

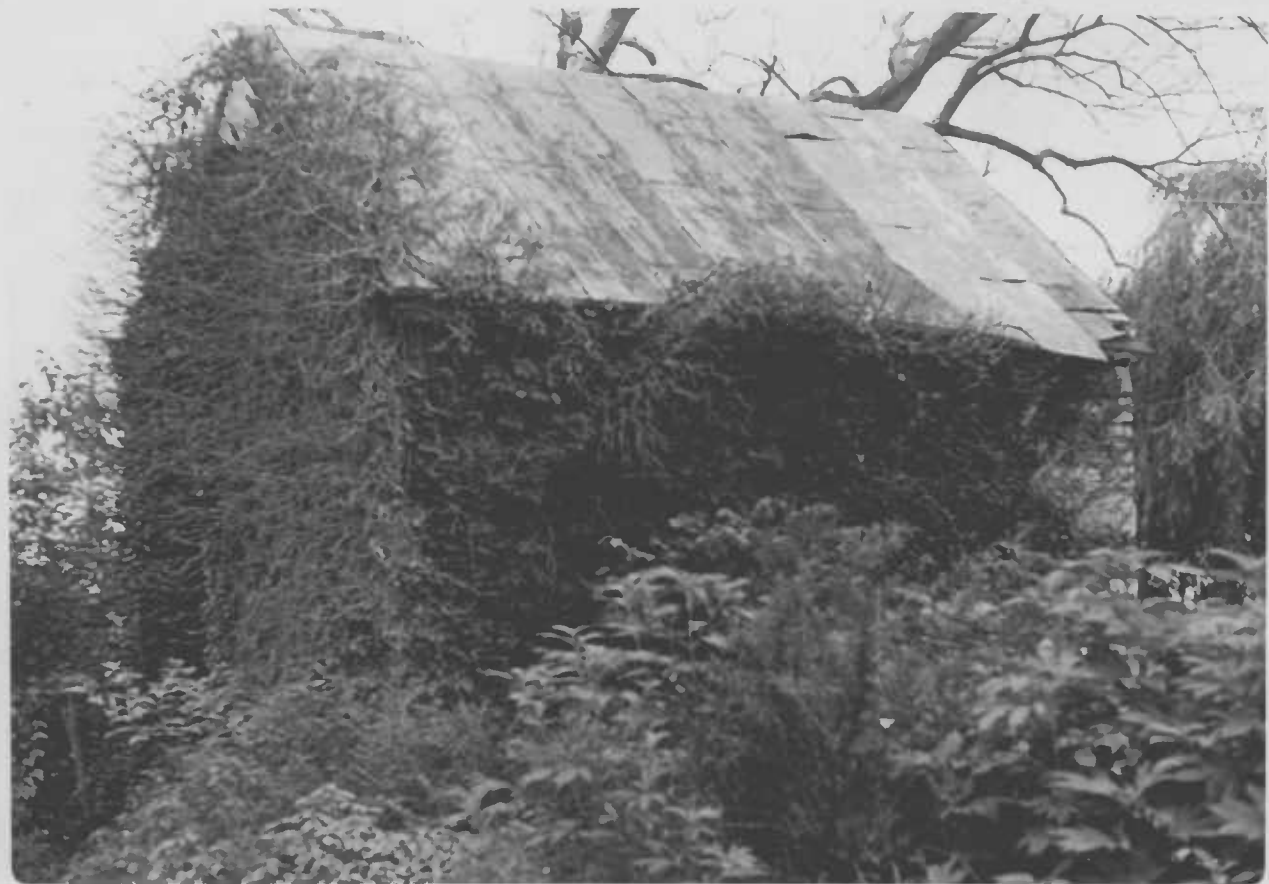
F-8-35

To the west of the house is a small stone outbuilding used as a springhouse due to its proximity to Israel's Creek. The structure is constructed of quarried stone, coursed in that section of the structure that faces the front drive. A standing seam tin roof partially covers the original wooden shingles visible on the west side of the roof.

Stone Spring Horse
